**REVISED COMPENSATORY MITIGATION PLAN  
FOR THE HOTEL WHARF AND ACCESS ROAD  
MAINTENANCE AND REPAIR PROJECT  
APRA HARBOR, GUAM**

Revised December 2019

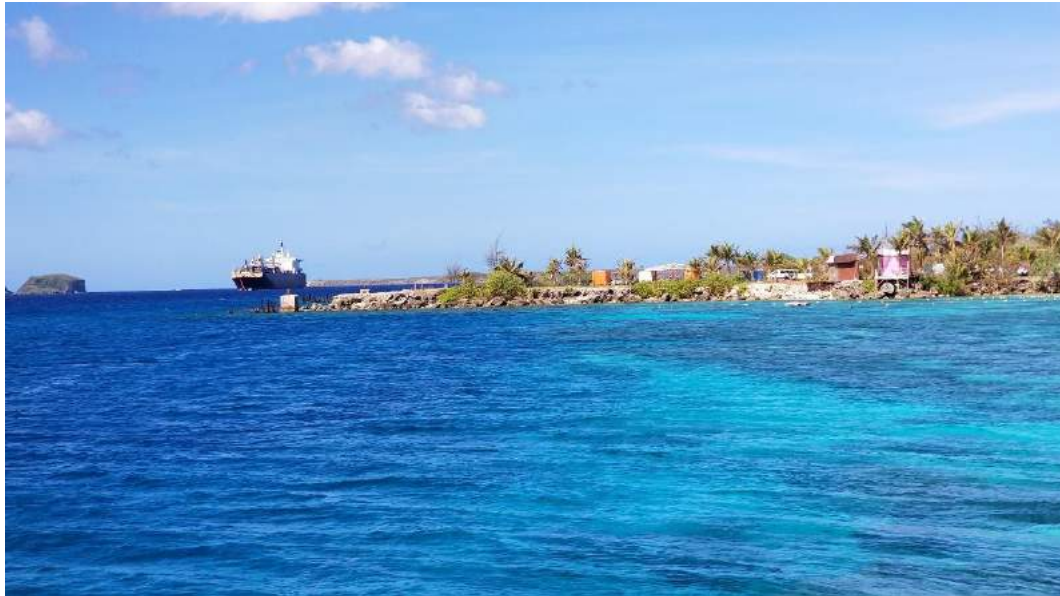
Photo 1. East pier of Dog Leg Pier, facing west, March 2019.

Coral colonies identified for relocation within the Direct Impacts Zone will be moved from Hotel Wharf and the surrounding substrate to a relocation site located at Dog Leg Pier, approximately 700 linear ft. (213 m) to the west of Hotel Wharf (Photo 1).

This relocation site was selected based on several key criteria, including: 1) close proximity to the project site; 2) presence of similar coral species and reef composition; 3) suitable hardbottom substrate devoid of coral on which to attach relocated colonies; 4) similar water depth and conditions; and 5) assurance from PAG that the relocation site would be protected through land use controls and committed to this use in perpetuity. While the recipient site is considered close, there is sufficient separation and protection from the impact site at Hotel Wharf through best management practices to minimize the potential for impacts during construction, such as sediment and vessel anchoring.

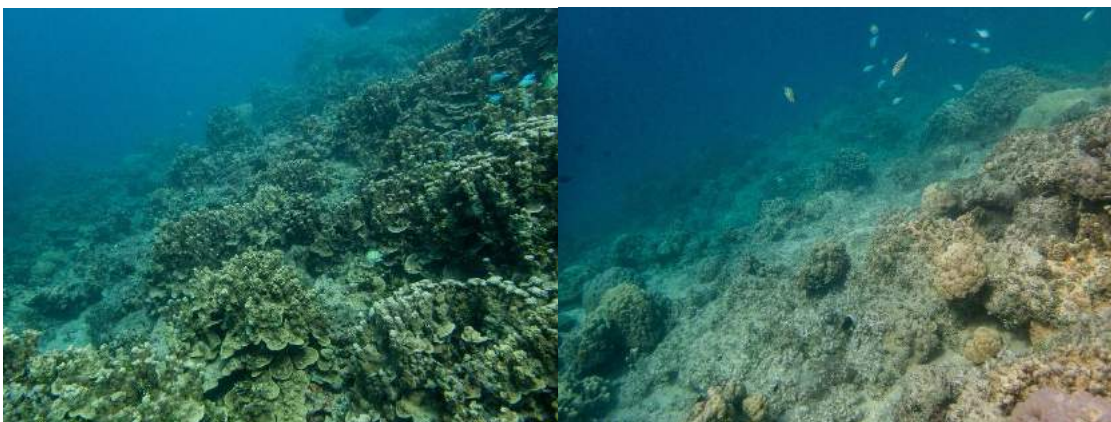
Photo 3. Reef slope with dense *Porites rus* colonies (left) and patches of reef rock with low coral cover (right) at Dog Leg Pier. *Courtesy of D. Burdick.*

The 200 m extent of reef slope investigated stretches from an area approximately 40 m west of the west “pier” to an area approximately 20 m east of the east “pier.” The benthic community along this portion of reef slope primarily comprises dense *Porites rus* growth, but patches of “bare” reef rock with low coral cover occur across the slope. While the area at the base of the slope primarily comprises sand, some patches of hardbottom with low-to-moderate coral cover were observed in the area just to the west of the west pier. The reef flat and slope extend approximately 400 m beyond the area investigated, to where the reef tract intersects with Dog Leg Reef, and 200 m to the east, where it meets Hotel Wharf.

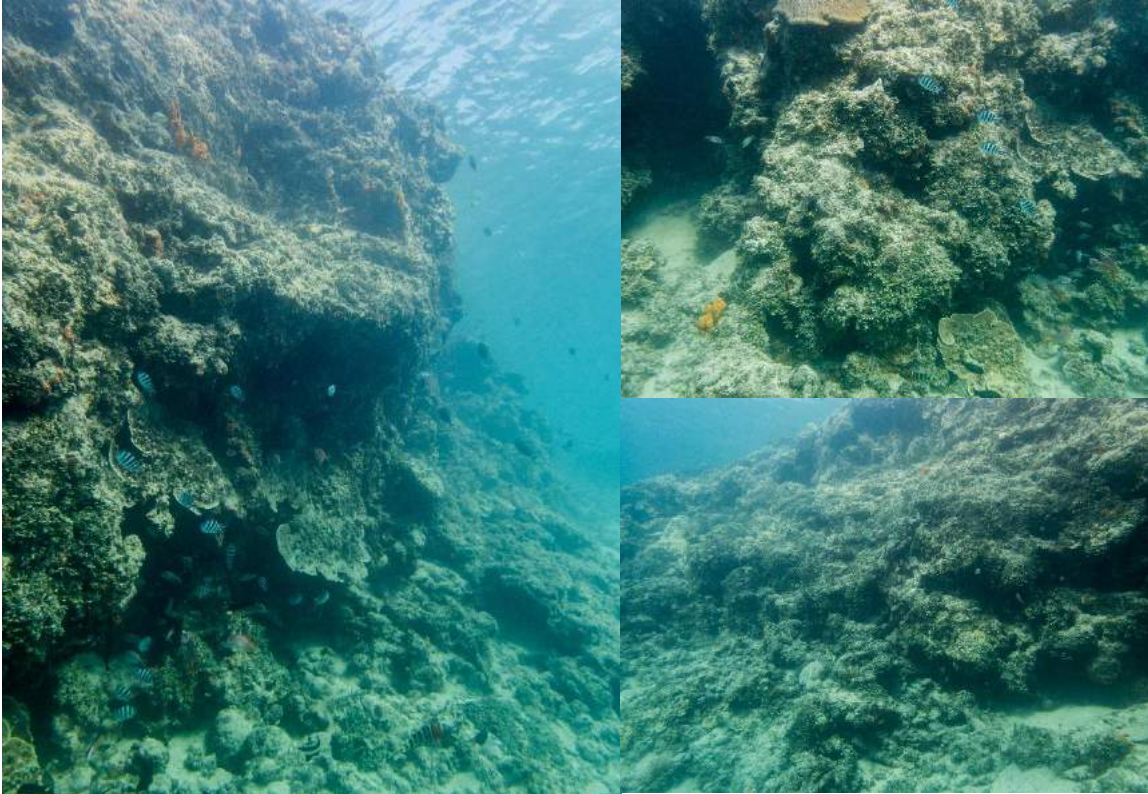
Photo 4. Near-vertical slope area west of west pier at Dog Leg Pier. *Courtesy of D. Burdick.*

A limited area of near-vertical slope occurring just to the west of the west “pier” at the Dog Leg Pier site may offer a similar environment for some of the *Lobophyllia cf. hataii* colonies and colonies of other shade-tolerant taxa (e.g., *Leptoseris* spp.) to be transplanted from Hotel Wharf, but the technical challenges of affixing relatively fragile colonies to a vertical structure may prevent the transplantation of these colonies or may require their transplantation to environments with non-preferred light levels (Photo 4).

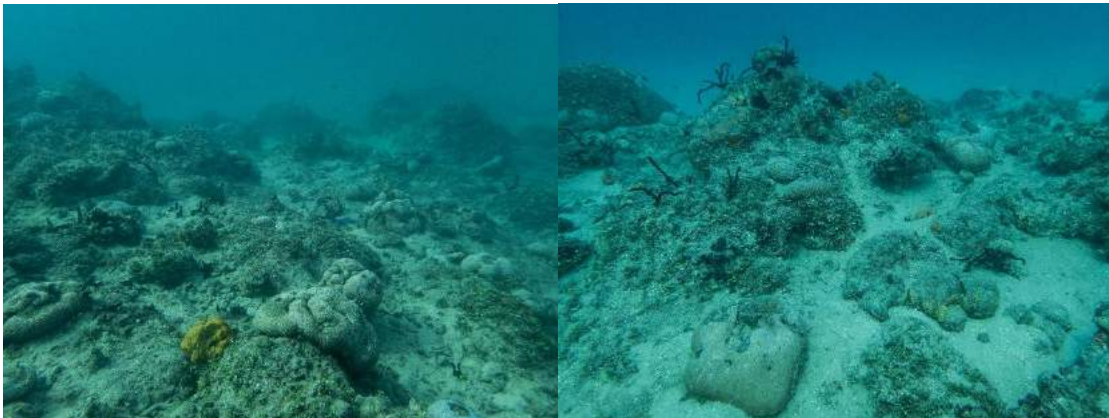
Photo 5. Sand and hardbottom along base of reef slope at Dog Leg Pier. *Courtesy of D. Burdick.*

The survey also considered potential areas for coral colonies that may be required to be transplanted from the debris and patches of hardbottom scattered across the sand flat within the Indirect Impacts Zone of the Hotel Wharf project site, although relocation of these colonies is not proposed by PAG at this time. If such an action is mandated, these colonies could be placed on hardbottom along the deeper portion of the reef slope at Dog Leg Pier (to better match light conditions) or along the patches of hardbottom extending southward from the base of the reef slope near the west “pier” (Photo 5).

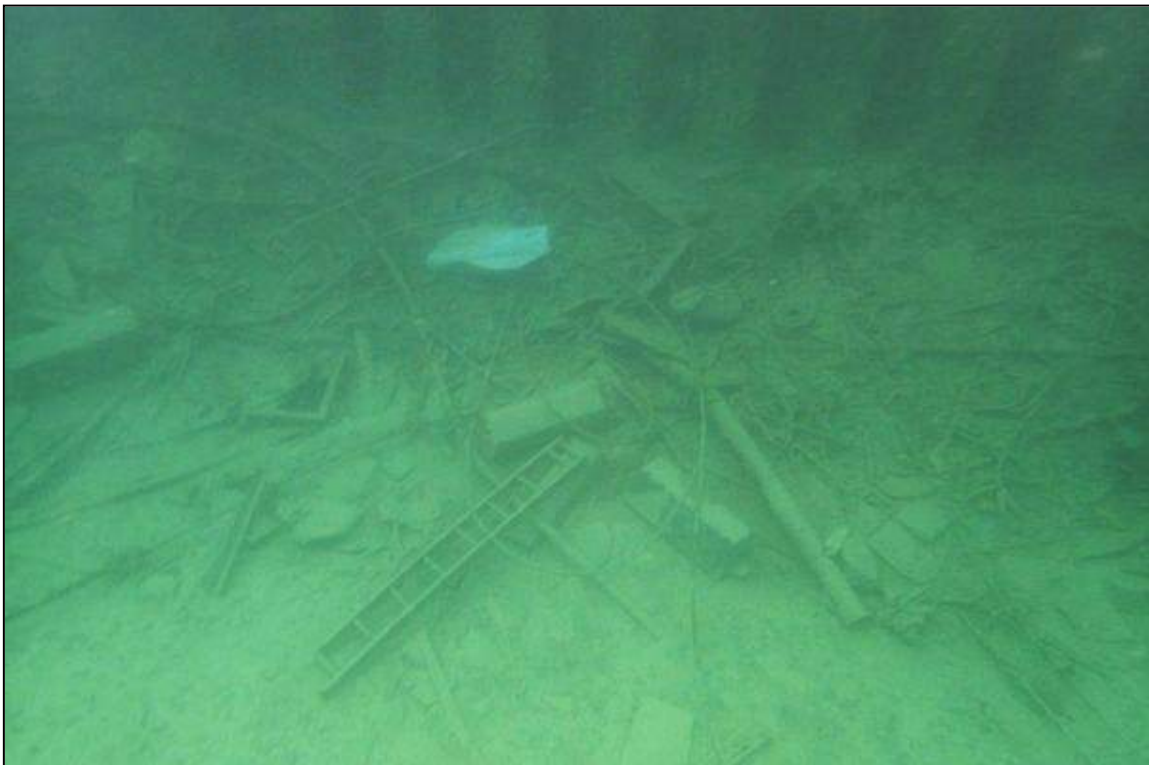
Photo 6. Example of marine debris along the south face of Hotel Wharf within the Direct Impacts Zone, February 2019 (Courtesy of D. Burdick).

The marine debris observed during marine surveys in January and February 2019 within the Direct and Indirect Impacts Zones comprised materials such as rope, pipe, metal fragments, tires, and various types of household waste including soda cans, bottles, and clothing (Personal observation, D. Keogh, DCA) (Photos 6 and 7).

Debris associated with past land use has accumulated around Hotel Wharf, particularly along the wharf base. Since debris will be removed from the seafloor surrounding Hotel Wharf, there are no alternative sites proposed or feasible for this mitigation measure.
